## **IDENTIFICATION OF EROSION SUSCEPTIBLE RIVER BANK SITES OF KALINDRI RIVER, MALDA DISTRICT, WEST BENGAL**

Kalindri River in Malda district, West Bengal displays varying degree of erosion. The Kalindri is the branch of River Phulhar experienced severe channel change due to lateral shifting associated with bank erosion over course of time. River bank erosion is a natural process and severe bank erosion has serious consequences for physical and biological processes of environment. In some villages around the Kalindri River bank erosion creates serious problem for the people living their destroying their crops. To predict the bank erosion the multi metric tool Bank Erosion Hazard Index is calculated. BEHI takes into consideration several aspect of bank condition and provides an overall score that can be used to predict the bank erosion over a large area. This paper mainly focuses on identification of potential river bank erosion risk sites along river Kalindri using some other scores like stability scores and ribbon testing, Erosion rate. After constructing models using those methods it is also tried to validate all of these in reference to each other in the one hand and with actua

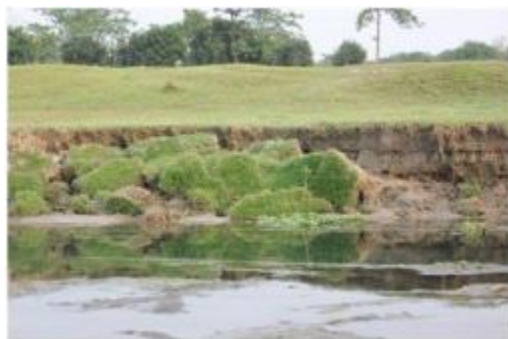
**Figure 2: Erosion, Left Bank, 70m Upstream Madia Ghat, 2015**

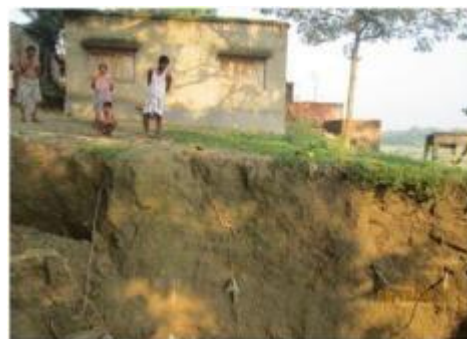
**Figure 3: Erosion, Right Bank, 100m Upstream from Nimasarai Ghat, 2015**

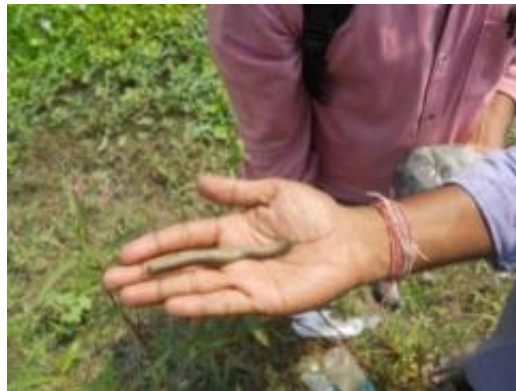
**Figure 5: Ribbon Test in Left Bank of Kalindri in Nimasarai, September, 2014**

A more semi quantitative assessment of bank material cohesiveness is ribbon test. At first a ball of soil with equal volume was taken in the palms of hand and it was rolled into a cigar shape by pushing the soil out between the thumb and fore finger. Then it was squeezed upward into a ribbon. The ribbon was made of uniform thickness and width. Finally the ribbon was allowed to emerge and extend over the forefinger and it will help to break the ribbon from its own weight.

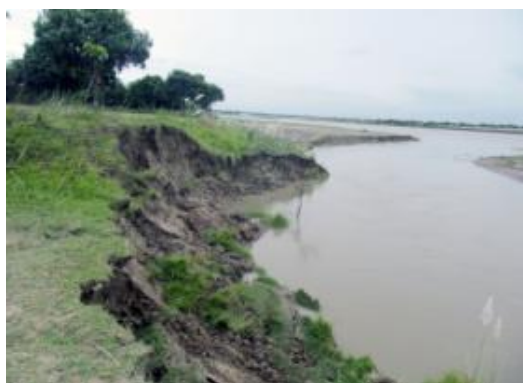
**Figure 8: Bank Erosion, Right Bank of Kalindri, Najirpur, 2015**

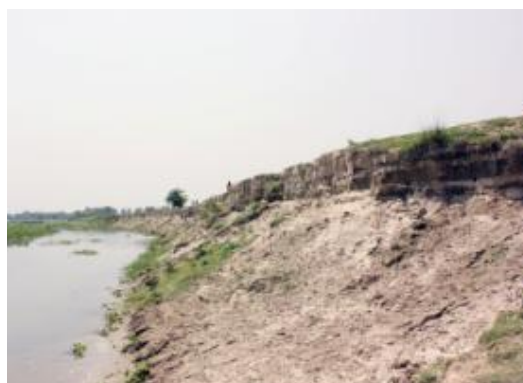
**Figure 9: Bank Erosion, Left Bank of Kalindri, Lakshmipur, 2014**

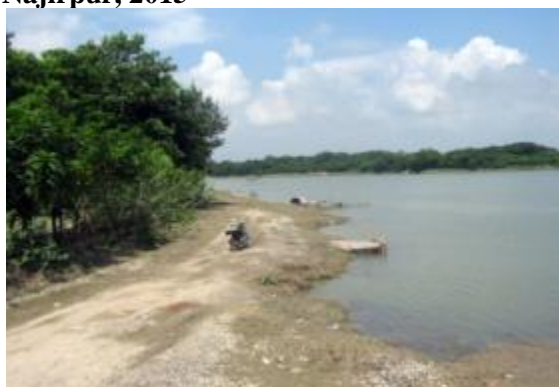
**Figure 10: Bank Surface Cover, Left Bank of Kalindri, Sailpur, 2014**

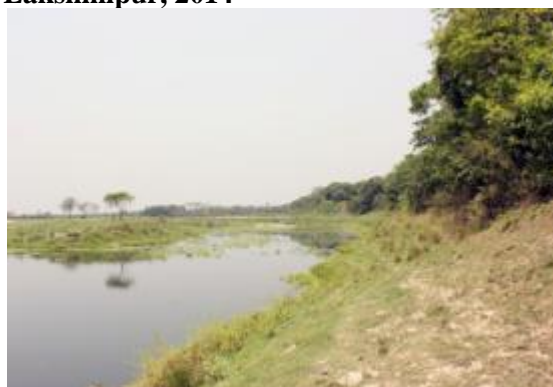
**Figure 11: Bank Surface Cover, Left Bank of Kalindri, Sailpur, 2014**

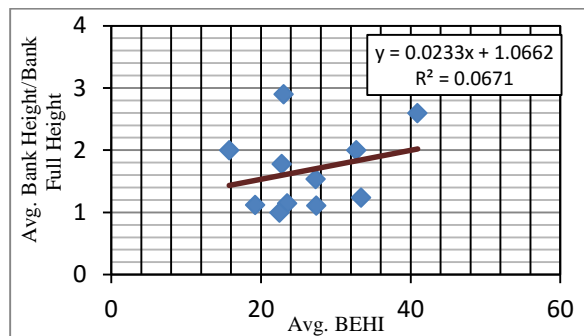
**Figure 12: Relation between Bank Height/Bank Full Height and BEHI**

Figure 12 to 16 represents the relationship between various parameters and total BEHI scores. Theoretically there is a positive relationship between average bank height/bank full height and average BEHI scores. The figure 12 displays same thing as the bank height/ bank full height increases the BEHI scores also increases. The figure 13 to 15 represents inverse relationship between various parameters (average root depth, average root density, average surface protection) and BEHI. The root density at Chandipur in K3 site almost 51% and the average BEHI score is 22.78. But Najirpur situated in K1 reach showing quite different results where root density is recorded almost 7.5 % and the average BEHI score is 40.92. Presence of low vegetation root density and depth at Najirpur represents high potentiality of erosion.

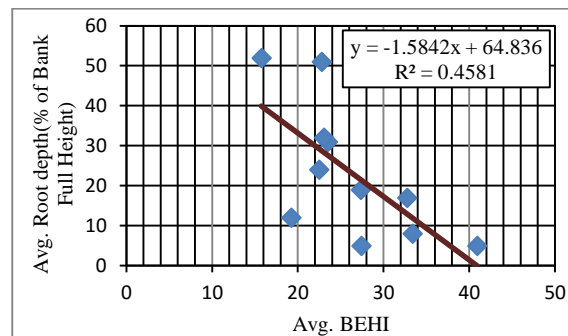
**Figure 13: Relation between Root Depth and BEHI**

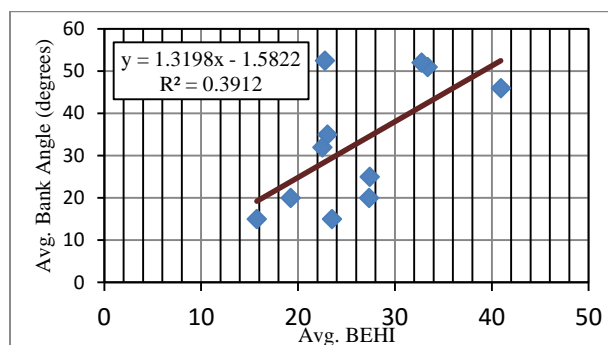
**Figure 16: Relation between Bank Angle and BEHI**
