Research Article

SOUQ AL WAKALA REHABILITATION PROJECT 'AN ARCHITECTURAL HERITAGE IN THE OLD CITY OF HEBRON-PALESTINE'

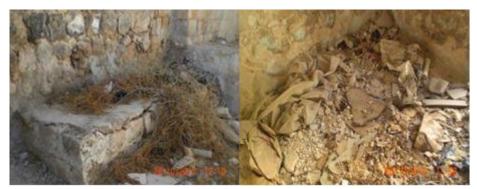
Figure 3: A banded building in the old Hebron city

As shown in figure 3, the building was abundant for several years, it was full of dogs, insects in addition to dead animals and bad abhors.

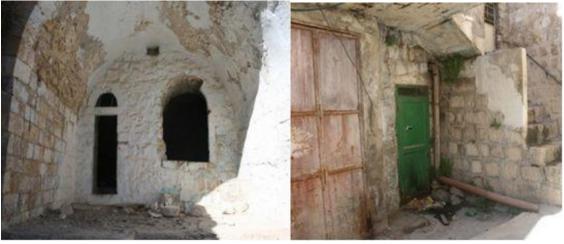
As shown in figure 5, many problems have to be taken into account to maintain it, such as:

- a. Water system;
- **b.** Sewage system;
- **c.** electrical system;
- **d.** broken windows, doors (been made out of wood);
- e. The plaster work which has deteriorated and flaked in places;
- f. The general cleanliness of the buildings, and the different types of flooring;
- **g.** The pointing (kuhla) on the walls;
- **h.** And the steps and the balustrades.

Figure 5: Some clear problems in the chosen building
